Image Artifacts in Backside Illumination CMOS Image Sensors Associated with Electrostatic Charge

Tom Frank, Tom Carducci, Bill Desjardin; *ON Semiconductor, Rochester, NY, USA*

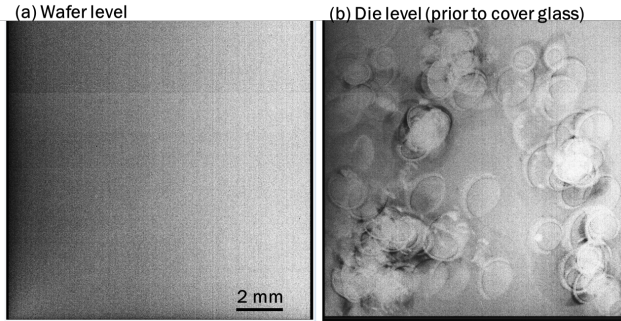
Bright field images at wafer level showed no unusual artifacts in the images (Fig. 3a). However, the die level bright field images often contained a large number of circular image artifacts (Fig. 3b) whereas dark field images were free of these artifacts. It was suspected that the bright field artifacts were due to a perturbation of the surface of the image sensor array, especially in the oxide layers. To test this idea, the dielectric layers were stripped using buffered HF for a die with imaging artifacts, then the die was remeasured (Fig. 4). The image artifacts are almost completely removed after the backside dielectrics are removed, indicating the image artifacts are due to a change in the backside dielectrics.

Figure 3. Bright field images for full array at (a) wafer level and (b) at die level. There are a large number of circular image artifacts at die level test.

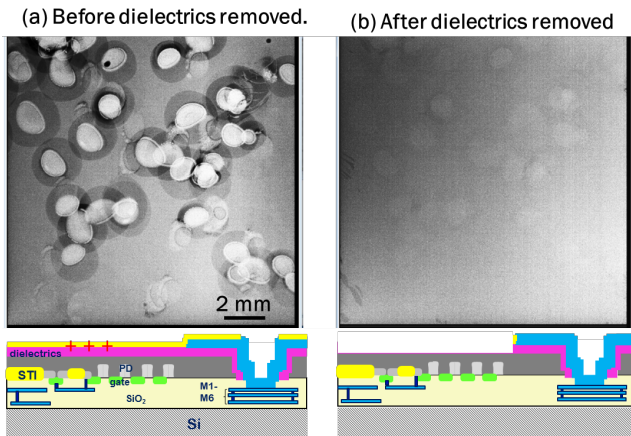
Figure 4. Bright field images at die level (prior to cover glass) for full array with (a) before and (b) after removal of backside dielectrics.

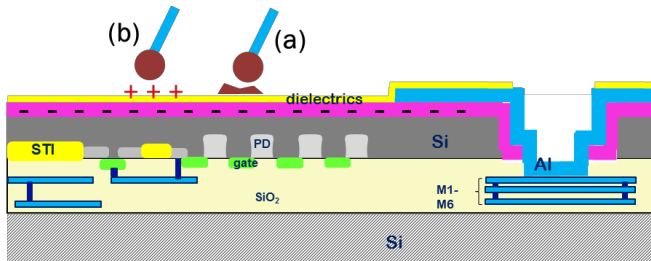
Two mechanisms were considered as the cause of the image artifacts during assembly; (1) contamination of the backside dielectrics or (2) electrostatic charging of the backside dielectrics (Fig. 5).

Figure 5. Possible mechanisms for imaging artifacts due to scrubbing with polymer-coated tip; (a) polymer residues and (b) electrostatic charging.

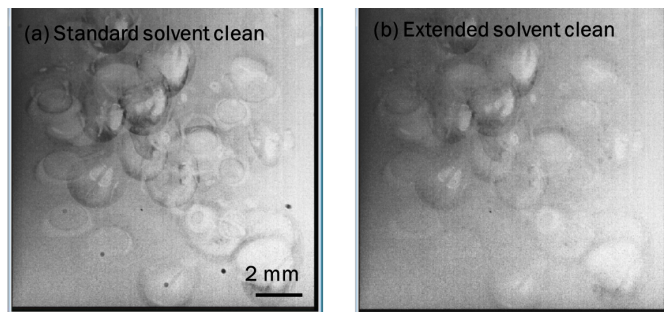
of contamination is associated with the mechanical removal of particles from the array, using a polymer-coated tip. In fact, the circular and localized appearance of the artifacts is consistent with scrubbing by polymer-coated tip. If polymer residues remain on the surface of the array from either of these processes, perhaps the residues could cause image artifacts. Extended cleaning with the organic solvents was evaluated on die that exhibited image artifacts to test this hypothesis (Fig. 6). There was no significant improvement in the image artifacts with extended cleaning suggesting that polymer residues are not the reason for the imaging artifacts.

Figure 6. Bright field images at die level (prior to cover glass) for full array with (a) standard solvent clean and (b) extended solvent clean.

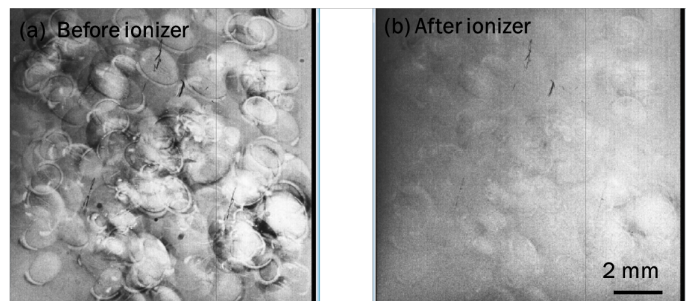
The hypothesis for electrostatic charging was tested by taking die with severe amounts of imaging artifacts and exposing them to an ionizer for 24h. The imaging artifacts are almost completely removed after the ionizer treatment, supporting the

theory that the imaging artifacts are due to electrostatic charging (Fig. 7). An additional experiment was conducted by rubbing the cover glass on fully assembled die with a rubber glove. These die also had imaging artifacts, which could be removed by using an ionizer, consistent with electrostatic charging (Fig. 8).

Figure 7. Bright field images at die level (prior to cover glass) for full array (a) before and (b) after exposure to ionizer for 24 h.

Clearly the imaging artifacts are undesirable and must be minimized. This work shows that precautions should be taken during assembly to minimize any electrostatic charging near the surface of the BSI image sensor.

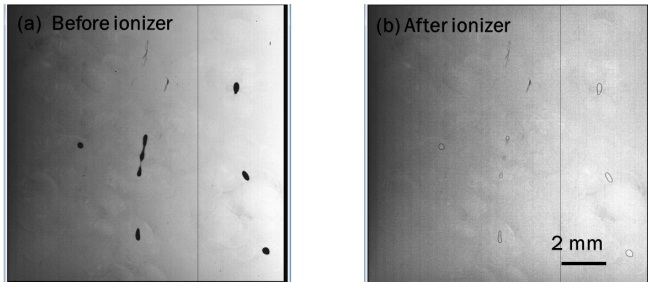
Figure 8. Bright field images at die level for parts with cover glass for full array (a) before and (b) after exposure to ionizer for 65 h.

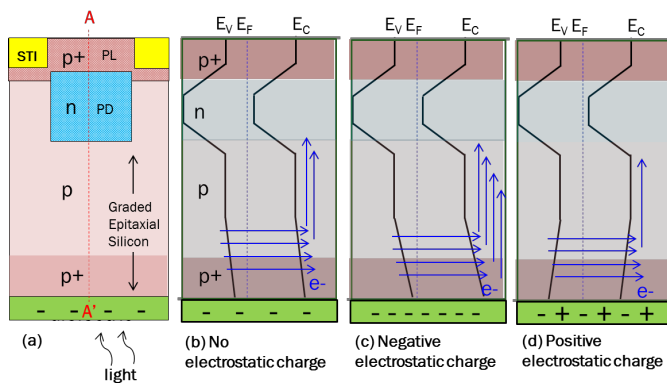
The imaging artifacts can be either brighter or darker than the background level under illumination (see Fig. 4 for example). A possible explanation for these results is based on band bending at the backside of the Si as a result of the electrostatic charge (Fig. 9). If the electrostatic charging increases the negative charge on the dielectric, the electric field is enhanced resulting in collection of more photogenerated electrons in the photodiode, leading to a

higher signal in the affected pixels. In contrast, if the electrostatic charging increases the positive charge on the dielectric, the electric field is reduced resulting in collection of less photogenerated electrons in the photodiode, leading to a lower signal in the affected pixels.

Figure 9. Band diagram in the vertical direction of the photodiode (A-A') showing the effect of electrostatic charge on the collection of photogenerated electrons; (a) No electrostatic charge, (b) negative electrostatic charge, and (c) positive electrostatic charge.
