EFFECTS OF IONIZING RADIATION ON CHARGE-COUPLED IMAGERS

J. M. Killiany, W. D. Baker, N. S. Saks, and D. F. Barbe
Naval Research Laboratory
Washington, D.C.

The effects of ionizing radiation on three different charge-coupled imagers have been investigated. Device performance was evaluated as a function of total gamma ray dose. The principal failure mechanisms have been identified for each particular device structure. The clock and bias voltages required for high total dose operation of the devices are presented.

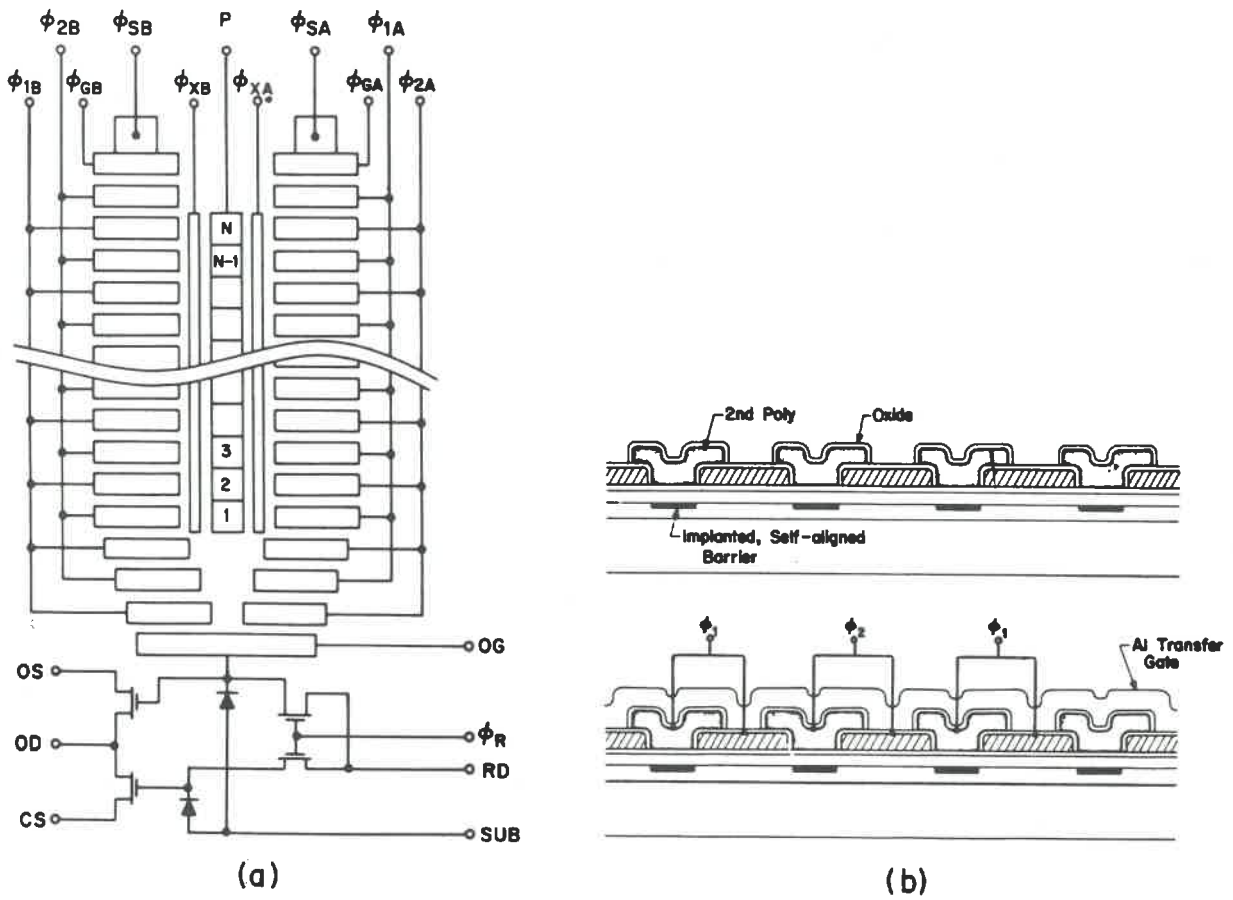
Figure 1. 256 x 1 CCD structure: (a) top view of the device; (b) cross-sectional view along the shift register

The test device is a 256-bit linear imager employing the double-register parallel transfer readout organization shown in Figure 1a (Ref. 6). The 256 photosites are separated by diffused channel stops and covered by a polysilicon photogate 23 μm wide. The center-to-center spacing of the photosites is 13 μm . The two-phase parallel shift registers have overlapping polysilicon gates and self-aligned ion implanted barriers. The right-left register outputs are interlaced at the output gate and fed into the gated charge integrator. The shift registers are designed to operate at 5 MHz with a resulting 10 MHz output data rate. The on-chip compensation amplifier can be used to suppress the reset clock noise by use of a differential amplifier in the external video circuitry.

A cross-section of the shift register is shown in Figure 1b. The gate insulator is a combination of an oxide and a nitride (Si_3N_4) layer. The self-aligned barrier is formed by means of a boron implant. The shift registers are covered with aluminum to prevent the incident light from going through the polysilicon gates and smearing the image.

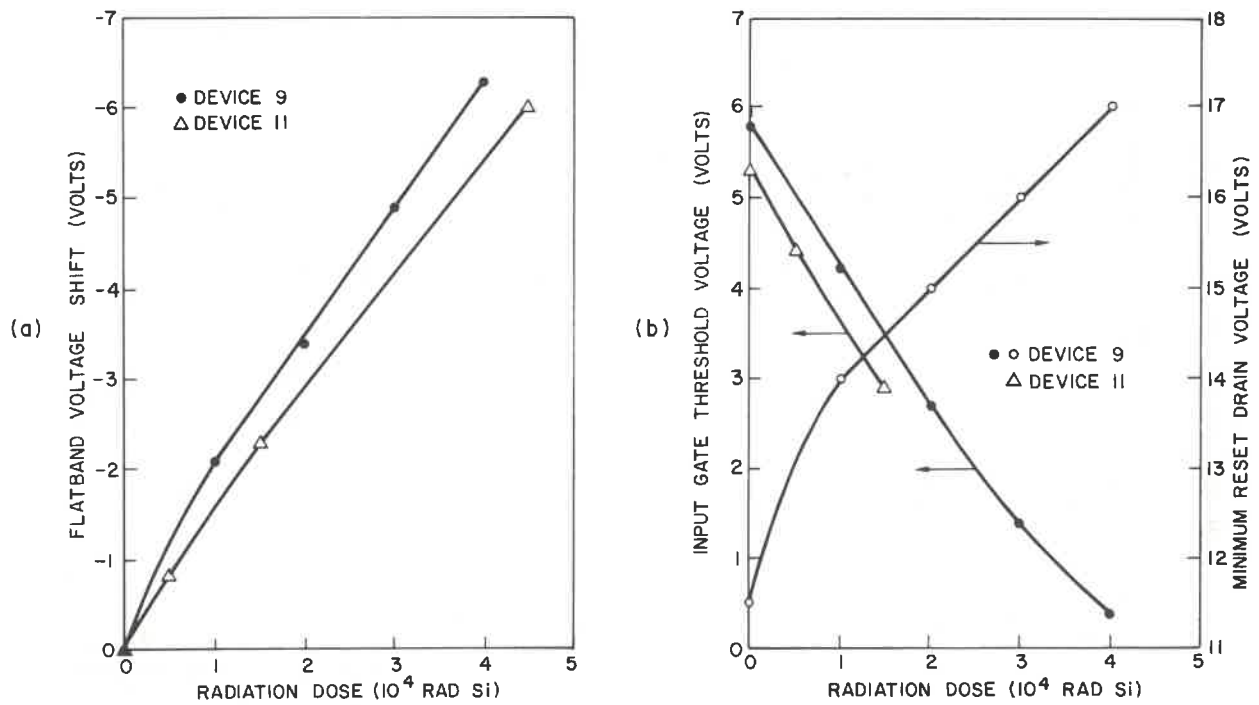
Figure 2. (a) Flat-band voltage shift vs. total dose for 256 X 1; (b) input gate threshold voltage and minimum reset drain voltage vs. total dose for 256 X 1

The radiation-induced flat-band voltage shift (ΔV_{FB}), shown in Figure 2a, limited device operation with the pre-irradiation clocks and bias to 4.5×10^4 rads (Si). The failure mechanisms resulting from ΔV_{FB} were: (1) buried channel driven out of depletion, (2) reset transistor biased in the conducting state for the entire clock period, and (3) input gate turned on. These three effects will be discussed separately in the following paragraphs.

The input gate threshold voltage as a function of dose is shown in Figure 2b. For a pre-irradiation input gate voltage of 0 V, the input would be turned on at 4.5×10^4 rads, filling the shift register wells. Saturation of the imager shift register can be avoided by simply increasing the reverse bias on the input diode while biasing the input gate to a negative voltage. In order to apply an analog signal to the shift register, a more sophisticated input scheme which minimizes the effect of the flat-band voltage shift must be employed since the input gate voltage swing between threshold and full-well is only about 0.5 V (Ref. 7).

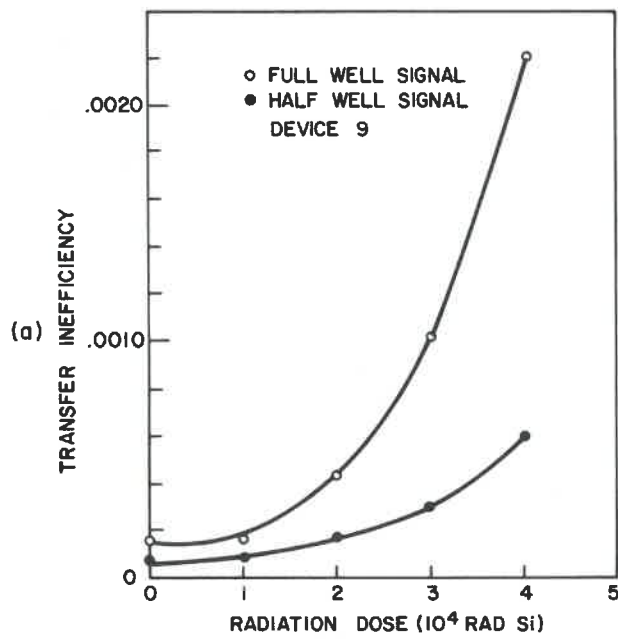
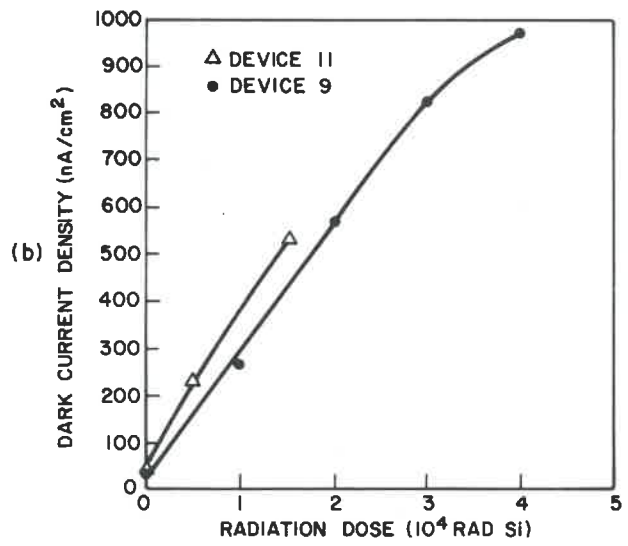
Figure 3. (a) Transfer inefficiency vs. total dose for 256×1 ; (b) dark current density vs. total dose for 256×1

The transfer inefficiency as a function of dose for electrically introduced full-well and half-well signals is shown in Figure 3a. The larger increase in the inefficiency for the full-well signal can probably be attributed to increased interface trapping. The interface state density as measured by a G-V technique was $1.3 \times 10^{10} / (\text{cm}^2 \text{eV})$ at 0 rads and increased to a value of $6 \times 10^{10} / (\text{cm}^2 \text{eV})$ at 4.5×10^4 rads. At 4×10^4 rads, a measurement of inefficiency vs. signal amplitude showed a sharp increase in loss for signals greater than 50% full-well. The inefficiency for 25% full-well was approximately the same as the 50% full-well value. A larger inefficiency for signals greater than 50% full-well is expected since the buried-channel device is operating in the surface-channel mode with increased interface state trapping (Ref. 8).

The increase in the thermally generated charge (dark current) density as a function of dose is shown for both devices in Figure 3b. The 27-fold increase at 4×10^4 rads would restrict operation to short integration times (i. e., the wells are filled with the dark charge in approximately 17 ms) or require cooled operation.

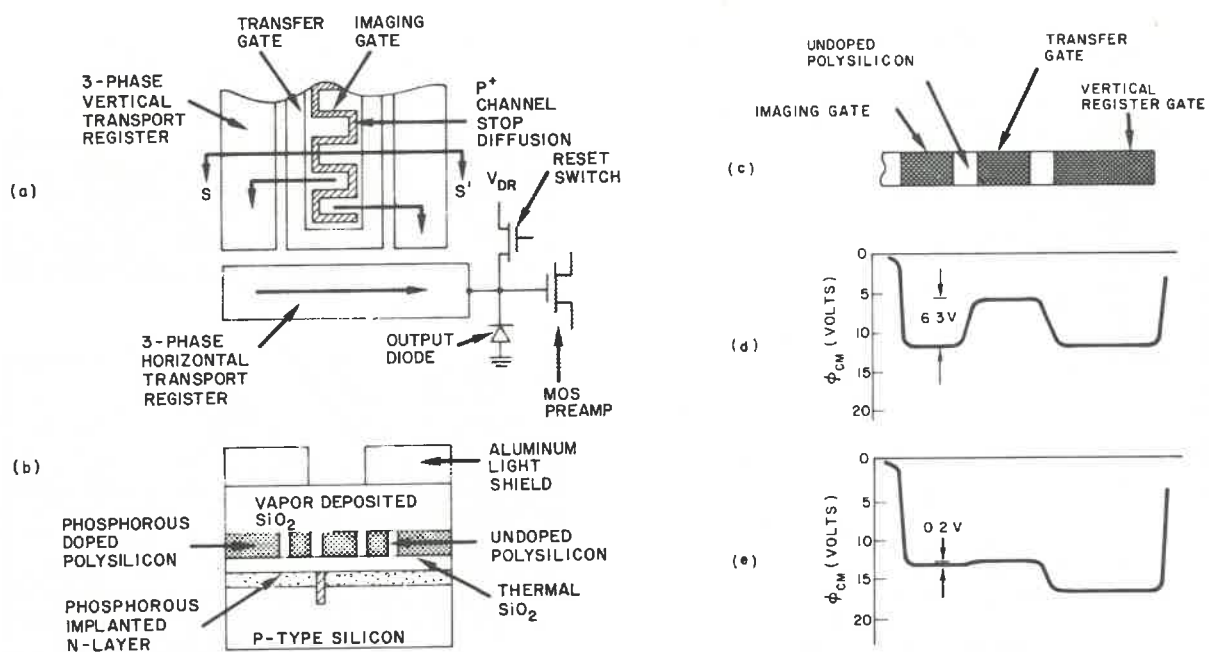
Figure 4. 60 x 1 CCD structure and potential profiles: (a) top view; (b) cross-sectional view; (c) cross-section of the gate structure; (d) pre-irradiation profile of the maximum channel potential; (e) profile of the maximum channel potential after 3×10^4 rads

This device, with a structure as illustrated in Figure 4, is a three-phase buried-channel CCD with planar, doped polysilicon electrodes and high-resistivity polysilicon interelectrode isolation. The substrate is 60-95 ohm-cm p-type silicon with $\langle 100 \rangle$ orientation. The channel oxide is thermally grown by a dry oxide technique and is 1800 \AA thick. Ion implantation of phosphorus through the oxide is used to form a buried-channel 3000 \AA thick with an average doping of $3 \times 10^{16} \text{ cm}^{-3}$. A layer of high-resistivity polysilicon about 5000 \AA thick is deposited over the channel oxide. The electrode pattern is formed by selective phosphorus diffusion into the polysilicon sheet. A vapor-deposited oxide is used to protect the device from damage.

The resistivity of the undoped polysilicon isolation between the gate electrodes was reduced by a factor of approximately 20 after a total dose of 3×10^4 rads. This drop in the resistance was due to field-induced channeling in the undoped polysilicon as a result of trapped positive charge in the oxide. The lower isolation resistance allowed the various clock and bias voltages to mix together. The principal result of the mixing was that the transfer and imaging gate waveforms were altered such that almost no barrier existed between the photosensitive elements and the vertical transport registers. A cross-section of the device with calculated pre- and post-irradiation potential profiles is shown in Figures 4c through 4e. The barrier reduction allowed almost all of the photo-generated charge under the imaging gate to continuously spill into the vertical registers instead of being collected for an integration time prior to being transferred. As a result, the effective output signal was reduced to approximately 3% of the pre-irradiation full-well capacity. This observed reduction agrees well with that expected from the μ profile of Figure 4e. Consequently, these devices became inoperative at a total dose of 3×10^4 rads, and operation could not be recovered by adjusting the bias and clock voltages.

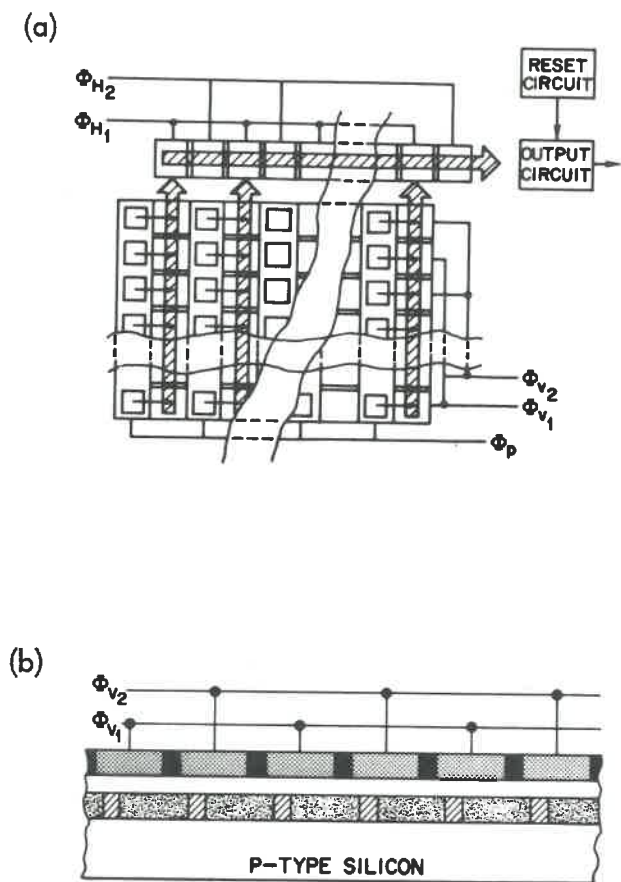
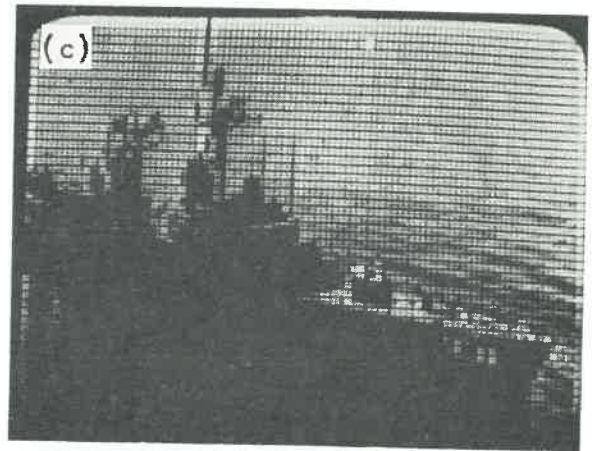
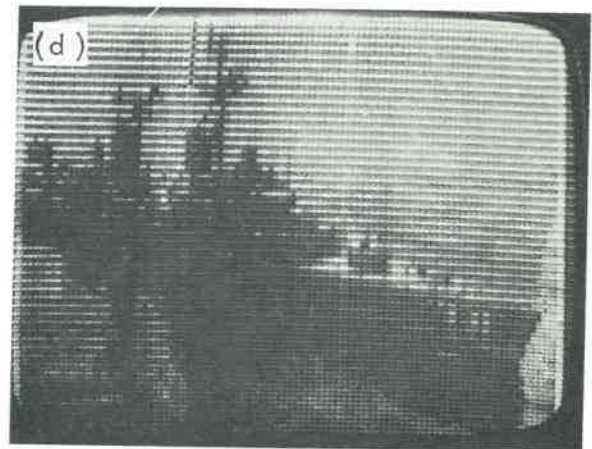
Figure 5. 100 x 100 CCD structure and image quality: (a) top view of the device; (b) cross-sectional view along a vertical transfer register; (c) pre-irradiation image; (d) image after 3×10^4 rads

The device consists of 10^4 photosensitive sites arranged in 100 columns, each containing 100 sites (see Figure 5a). Adjacent to each column of photosensitive sites is a vertical transfer register. The horizontal shift register is employed to multiplex the signals from the vertical registers. A differential FET amplifier on the chip provides the video output.

The device has the structure shown in Figure 5b. It is a two-phase, buried-channel CCD with ion-implanted barriers. The electrodes are doped polysilicon and the interelectrode isolation is high-resistivity polysilicon. The CCD substrate is 60-90 ohm-cm p-type silicon with $\langle 100 \rangle$ orientation. The channel oxide is 1200 Å thick and is grown by a dry oxide technique. Ion implantation of arsenic through the oxide is used to form an n-type buried channel with a thickness of about 3000 Å and an average doping of $1 \times 10^{16} \text{ cm}^{-3}$. The barriers necessary for two-phase operation are formed by implanting boron into the channel. A layer of high-resistivity polysilicon is deposited over the channel oxide. The electrode pattern is formed by selective diffusion into the undoped polysilicon sheet. A thick vapor-deposited oxide covers the device. Aluminum light shields are used to cover all of the active region except for the photosensitive areas.

resolution target range from 14 to 16 lp/mm vertically and from 11 to 12 lp/mm horizontally. A typical pre-irradiation image is shown in Figure 5c.

For a total dose of 1×10^4 rads, no change in the imaging quality of the devices was observable. At 3×10^4 rads, the image did deteriorate significantly. A qualitative demonstration of this is shown in Figure 5d. The limiting resolution at this total dose decreased to between 6 and 10 lp/mm vertically and between 5 and 6 lp/mm horizontally. At a total dose of 1×10^5 rads, no image at all was obtained with the original clock and bias voltages. After substantial adjustments of the operating conditions, a rather poor image could be recovered.
